Revision Guide for AMD Family 12h Processors

Publication # 44739	Revision: 3.08
Issue Date: January 2012

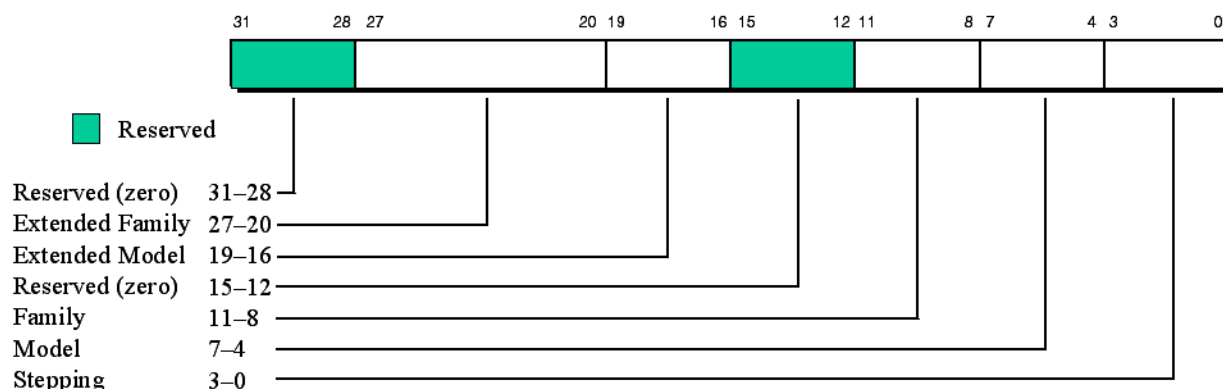
Figure 1. Format of CPUID Fn0000_0001_EAX

A processor revision is identified using a unique value that is returned in the EAX register after executing the CPUID instruction function 0000_0001h (CPUID Fn0000_0001_EAX). Figure 1 shows the format of the value from CPUID Fn0000_0001_EAX. In some cases, two or more processor revisions may exist within a stepping of a processor family and are identified by a unique value in D18F4x164 Fixed Errata Register (see page 15).
